# AIRCRAFT ACCIDENT REPORT

CONTROLLED FLIGHT INTO TERRAIN  
AIR CHINA INTERNATIONAL FLIGHT 129  
B767-200ER, B2552  
MOUNTAIN DOTDAE, GIMHAE  
APRIL 15, 2002

KOREA MINISTRY OF CONSTRUCTION AND TRANSPORTATION  
KOREA AVIATION-ACCIDENT INVESTIGATION BOARD

KAIB/AAR F0201  
Adopted March 4, 2005

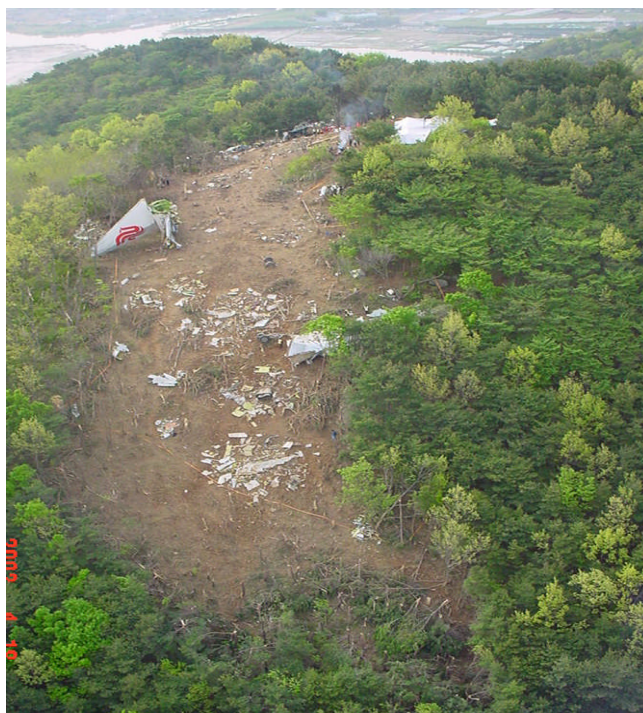
Figure 1-3 Site of Forest Damage

Damage to the forest on Mt. Dotdae of some 8,000 m<sup>2</sup>, including 12 grave sites, was caused by the aircraft’s impact with trees and the ground, along with the spread of the wreckage.<sup>14</sup>

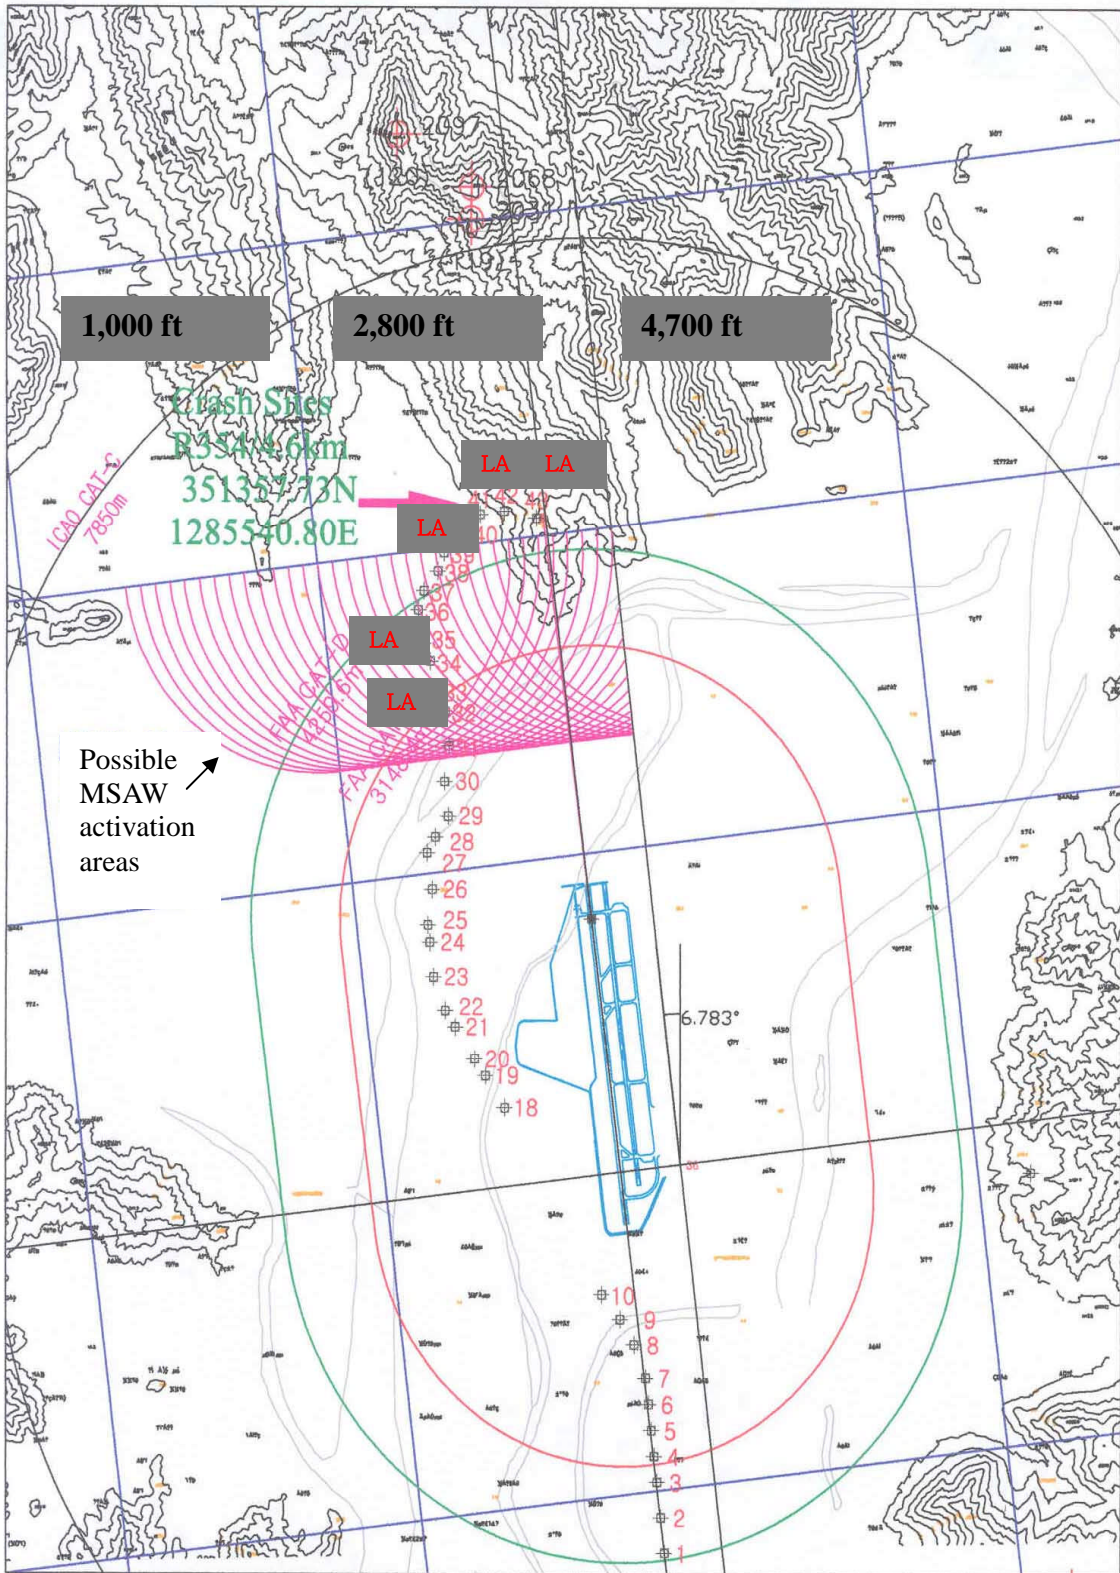
Figure 1-9 Possible MSAW Activation Areas and Circling Approach Area

<sup>61</sup> The areas where the predictive warning can be activated in accordance with flight distance by the aircraft heading and speed by means of MSAW predictive warning function (in the case of flight 129, the predictive warning was possible in front of about 1.4 NM, applying 170 kt of ground speed).

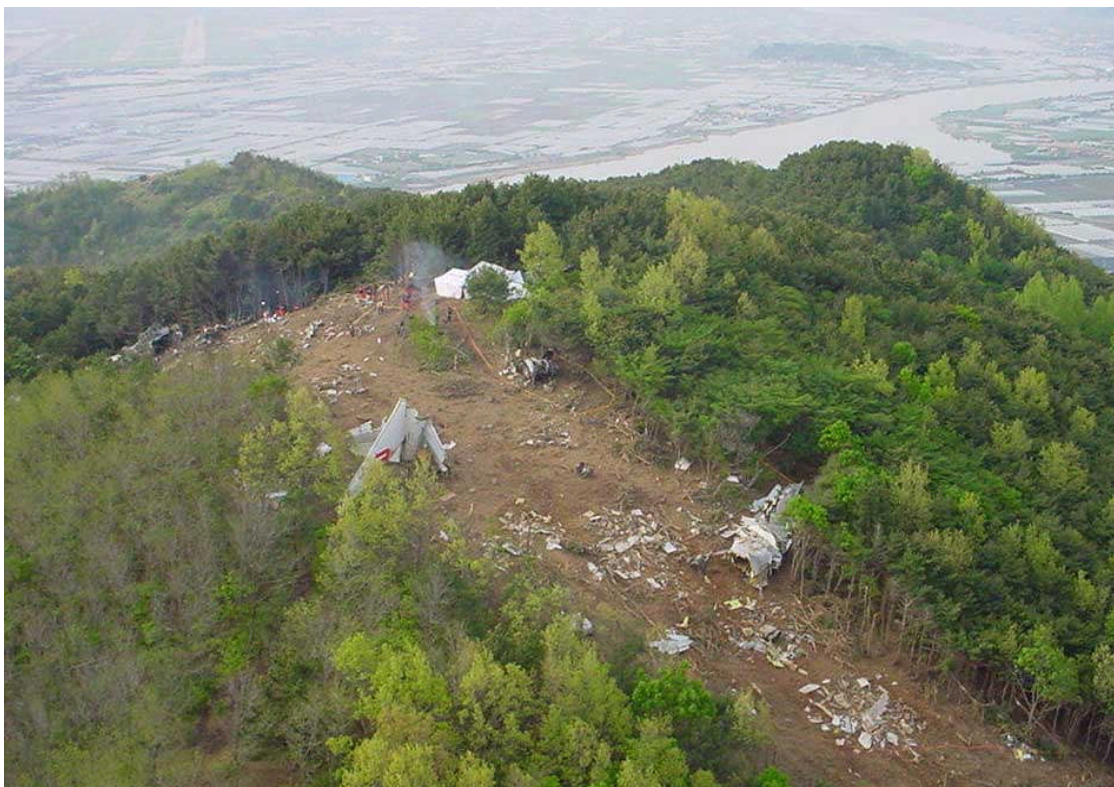
Figure 1-13 Photograph of the Accident Site

After the aircraft's impact with the ground, the right wing, empennage, left wing including parts of the fuselage, and two engines were separated respectively. The forward fuselage including the cockpit was totally consumed by a post impact ground fire.

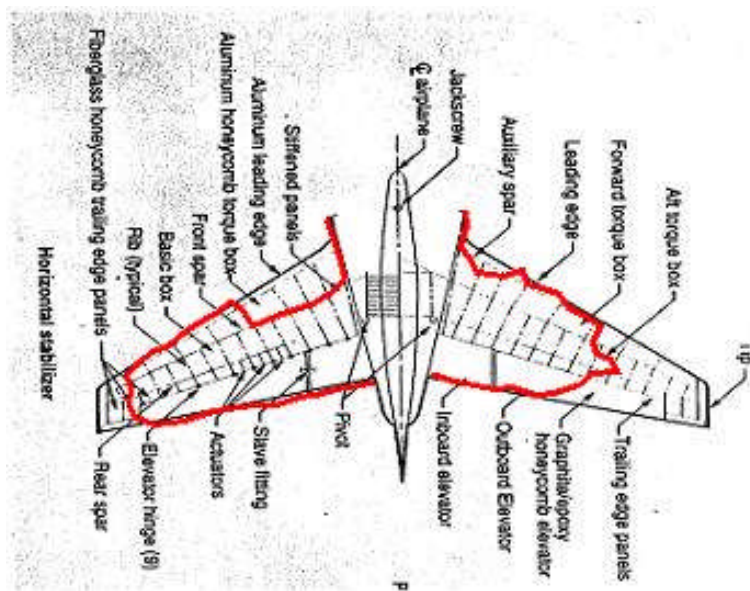
Figure 1-16 The Remaining Portion of the Wreckage (inner area of red line)

Both elevator tips were sheared off, with the elevators lying flat on the ground supporting the tail section upright.

The horizontal stabilizer's jackscrew extension was measured to be 14 inches between the lower gimbal assembly and the lower stop.

The front surface of the left horizontal stabilizer (as shown on Figure 1-16) was damaged and the tip was sheared off by an impact with the trees. While there were signs of the impact with trees on the front inner part of the left stabilizer, there was no sign of the preimpact skin corrosion or damage.

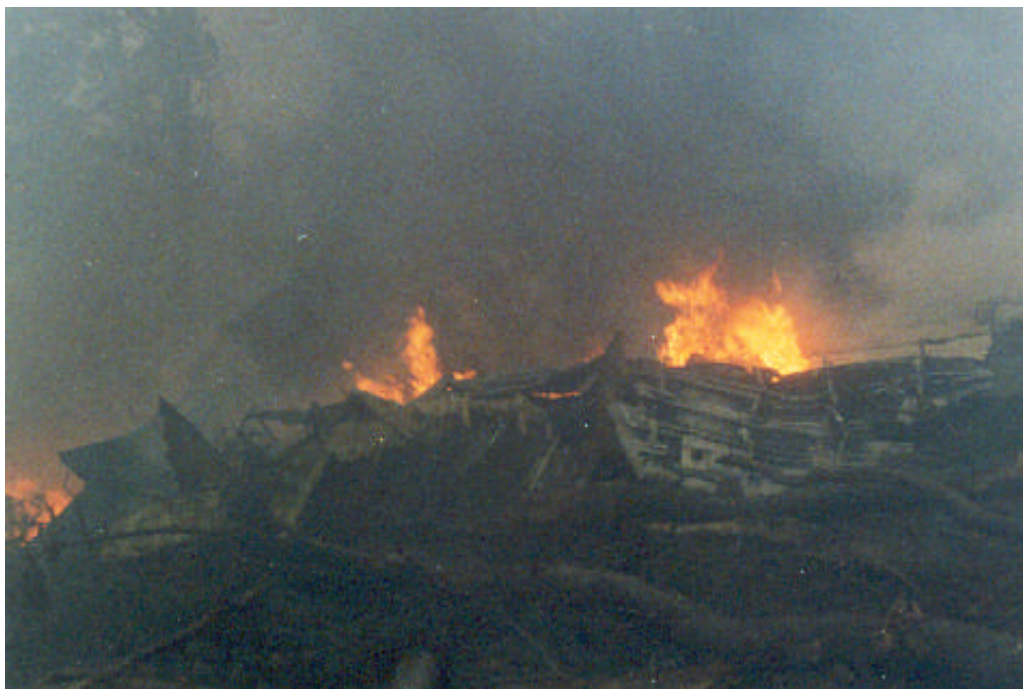
Figure 1-17 Photograph of the Aircraft on Fire after Crash

The on-scene investigation revealed no signs of fire on board the aircraft prior to crash. After the ground impact, the right wing and the empennage were separated from the fuselage. These items had no fire damage. The first sign of fire damage was found approximately 150 m from the initial point of impact.

At the accident site, it was raining with heavy fog. Fire fighters, soldiers and police struggled to apply dry chemical and halon fire extinguishing agents, and dirt to put out the fire, but the interiors of the cabin and flight deck were burnt completely, as shown on Figure 1-17. The fuselage fire, accompanied with exploding sounds and heavy smoke, was extinguished about 15:00 on the day of the accident.

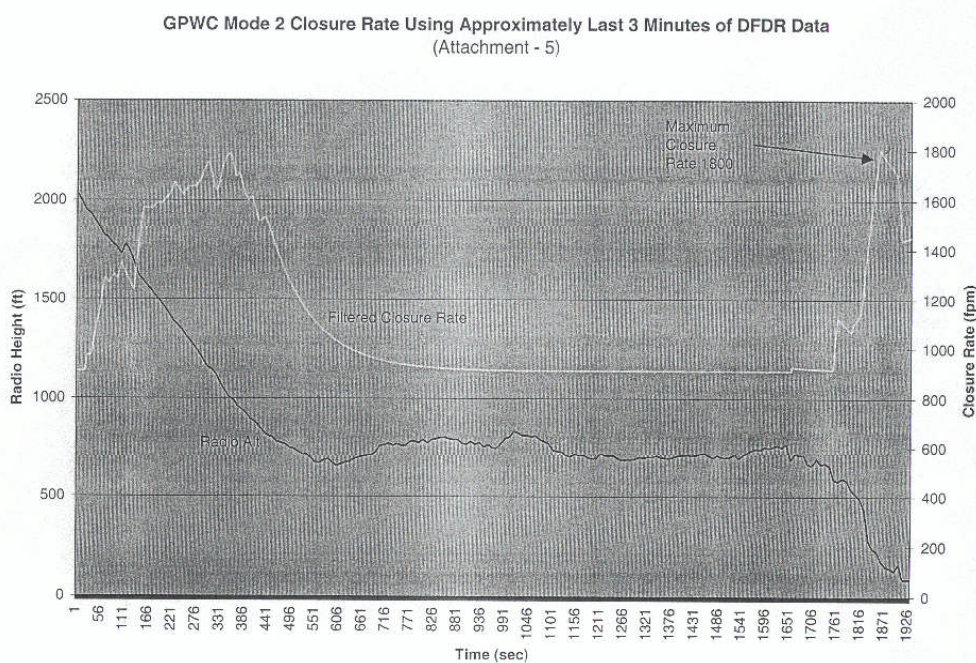
Figure 2-1: During the Last 3 Minutes of DFDR Data, GPWC Mode 2 Closure Rate

According to a close examination<sup>177</sup> by Boeing of the radio altitude data of the FDR, the descent rate for the last 3 minutes from an altitude of 2000 ft until the ground impact increased from about 900 fpm to 1800 fpm, and at 700ft on the circling approach, it decreased to 900 fpm. It again increased to 1800 fpm just before the impact, as shown in the figure 2-1.

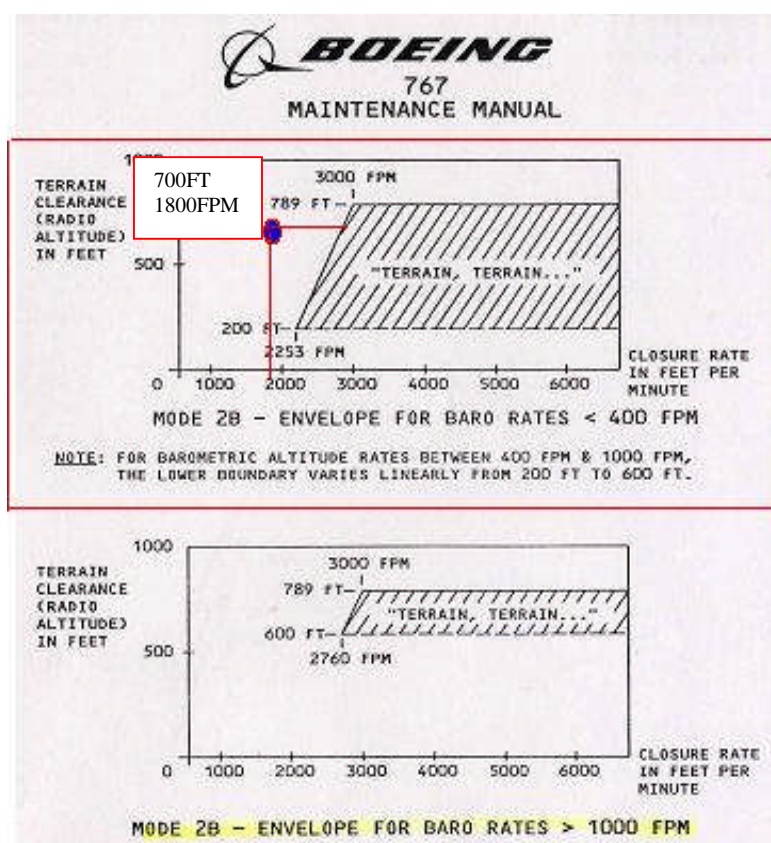
Figure 2-2 : Mode 2B Envelope for Barometric Rates < 400 FPM (Indication part)

The aircraft was in level flight and the baro rate was zero at the impact with Mt.Dotdae, which, as marked on the upper part of Figure 2-2, is applicable to Mode 2B-envelope for baro rate < 400fpm. According to the Figure, when the closure rate is 2,253 fpm~3,000 fpm, Mode 2 warning will be generated per design. In the case of flight 129, the maximum closure rate was 1,800fpm, which was outside the Mode 2B-envelope to generate the warning. Therefore, it was confirmed to be normal that the MK- III GPWC installed in the aircraft did not generate any warning.

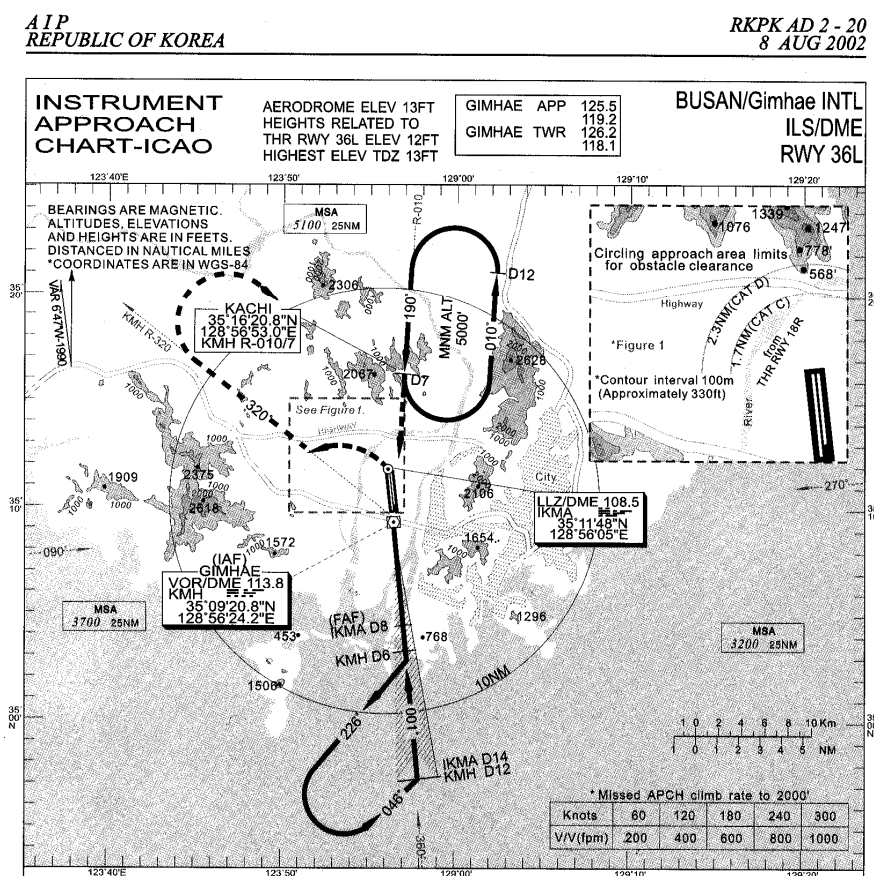
Figure 2-5 Gimhae Instrument Approach Chart (revised, effective August 8, 2002)

An instrument approach chart for the AIP revision of August 8, 2002, as shown in Figure 2-5, now has an inset on the upper right corner with a magnified view of the base turn area for runway 18 with contour lines, ground references, and category “C” and “D” turn radius, in order to promote a better understanding of the circling procedure of Gimhae airport.
