붙임 5 : GPWS 성능 분석 보고서

Subject: GPWS Performance Evaluation Report - Transmittal
Air China 767-200ER B-2552 Landing Accident Near Busan, South
Korea - 15 April 2002

Evaluation of GPWS Performance

Air China 767 Crash April 15, 2002 at Busan South Korea

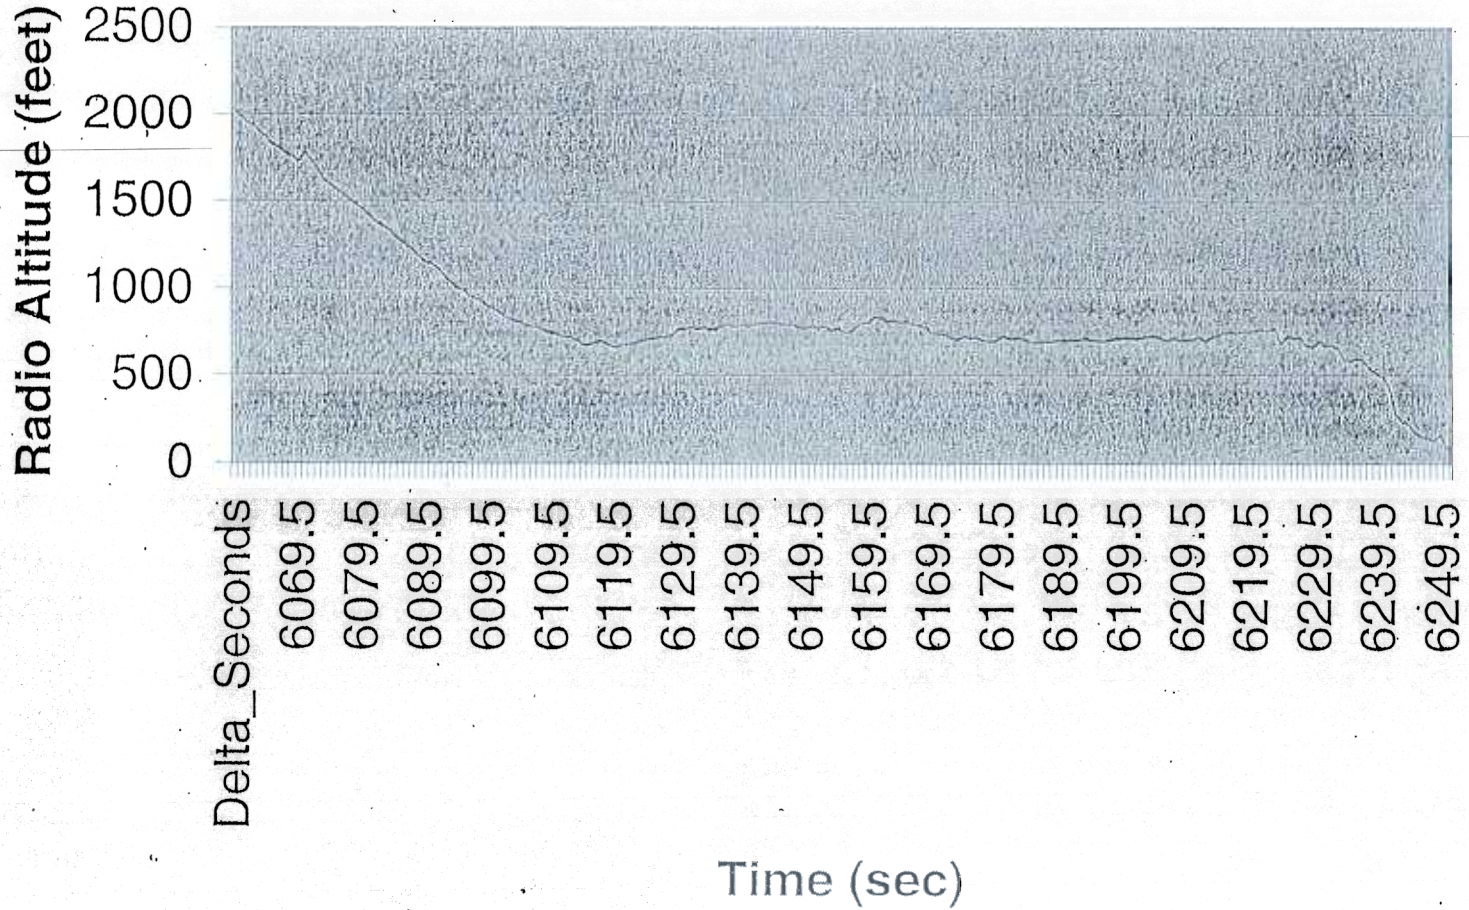
(attachment 3)

Radio altitude data from the DFDR was used to run a simulation using a MK-III GPWC. This radio altitude data is included (attachments 3 and 4). With the airplane configured to land, the alert threshold is defined by attachment 6. In order to avoid nuisance alerts during normal approach and landing, additional radio altitude filtering is applied to the calculated closure rate signal. The maximum filtered closure rate from the simulation was approximately 1800 feet per minute (attachment 5). This closure rate will not trigger the Mode 2B boundary (attachment 6)

Radio Altitude From DFDR - From Approximately Last 3 Minutes of Flight

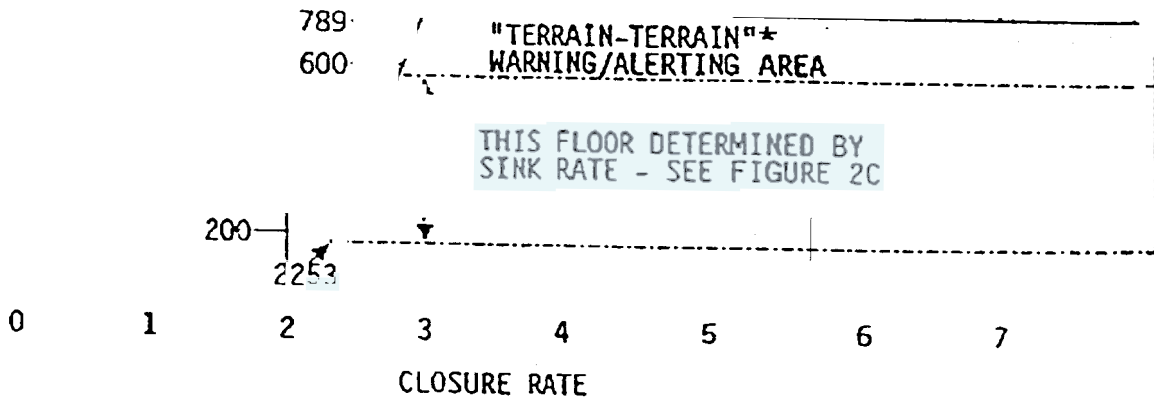
Mode 2B Closure Rate Envelope (Attachment 6)

Analysis - GPWS alerts possible given the airplane was configured for landing would be Mode 1 excessive descent rate or Mode 2B excessive closure rate. Mode 1 alerts can be immediately ruled out since the airplane was flying level. Mode 2 alerts were not triggered because the terrain closure rate magnitude and duration were less than that required to cause an alert with the gear and flaps lowered.

Tabular radio altitude data from the DFDR was used to run a simulation using a MK-III GPWC. The simulation confirmed that the closure rate was not sufficient to trigger the Mode 2B boundary.

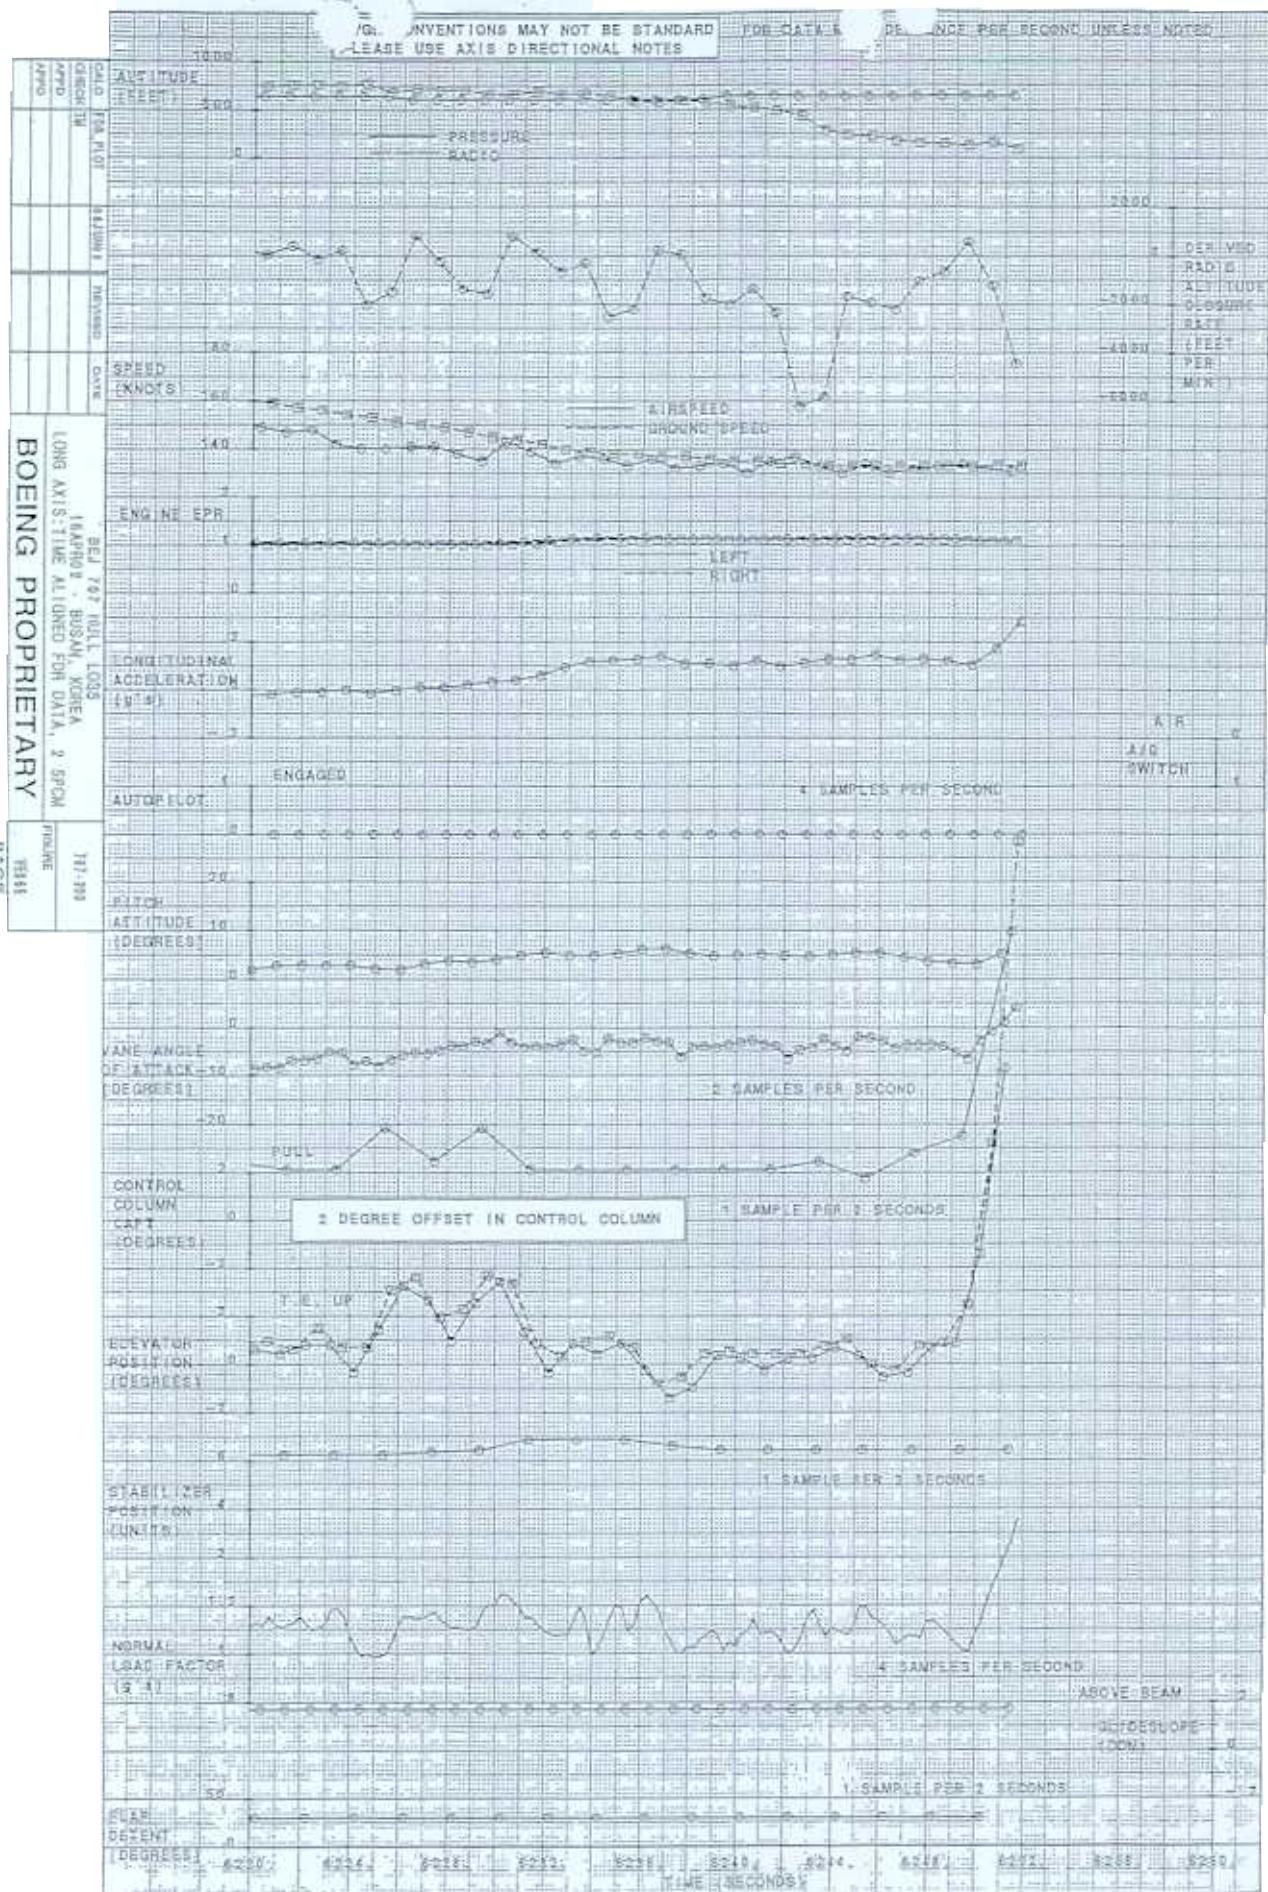
Attachment 7 is a plot of additional DFDR data used in the GPWS alerting analysis showing approximately the last 32 seconds of the flight.
