**General Administration of Civil Aviation of China**

**Comments on KAIB Aircraft Accident Report (Draft)**

**Aviation Safety Committee of CAAC**

## Comments on KAIB Aircraft Accident Report (draft)

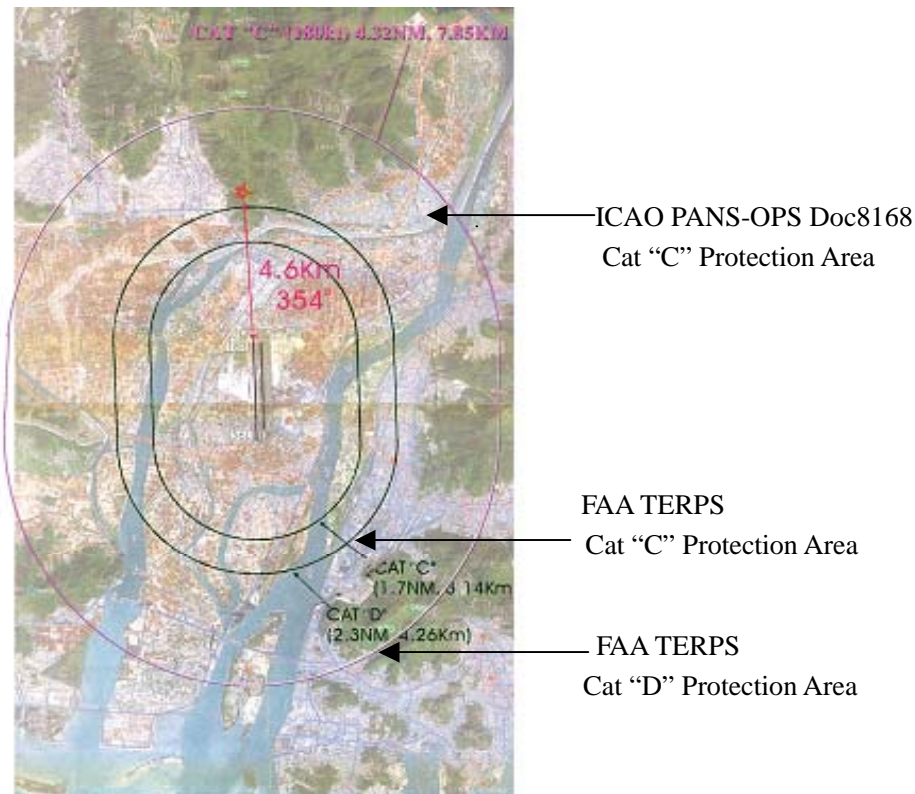
Figure 1 Relationship between aircraft crashed site and circling protection area

The aircraft crashed at a point 4.6 km form the runway threshold with true azimuth of 354°, which was outside TERPS Category "D" protection area but inside ICAO PANS-OPS Category "C" protection area.
