# AIRCRAFT ACCIDENT REPORT

CONTROLLED FLIGHT INTO TERRAIN  
AIR CHINA INTERNATIONAL FLIGHT 129  
B767-200ER, B2552  
MOUNTAIN DOTDAE, GIMHAE  
APRIL 15, 2002

KOREA MINISTRY OF CONSTRUCTION AND TRANSPORTATION  
KOREA AVIATION-ACCIDENT INVESTIGATION BOARD

KAIB/AAR F0201  
Adopted March 4, 2005

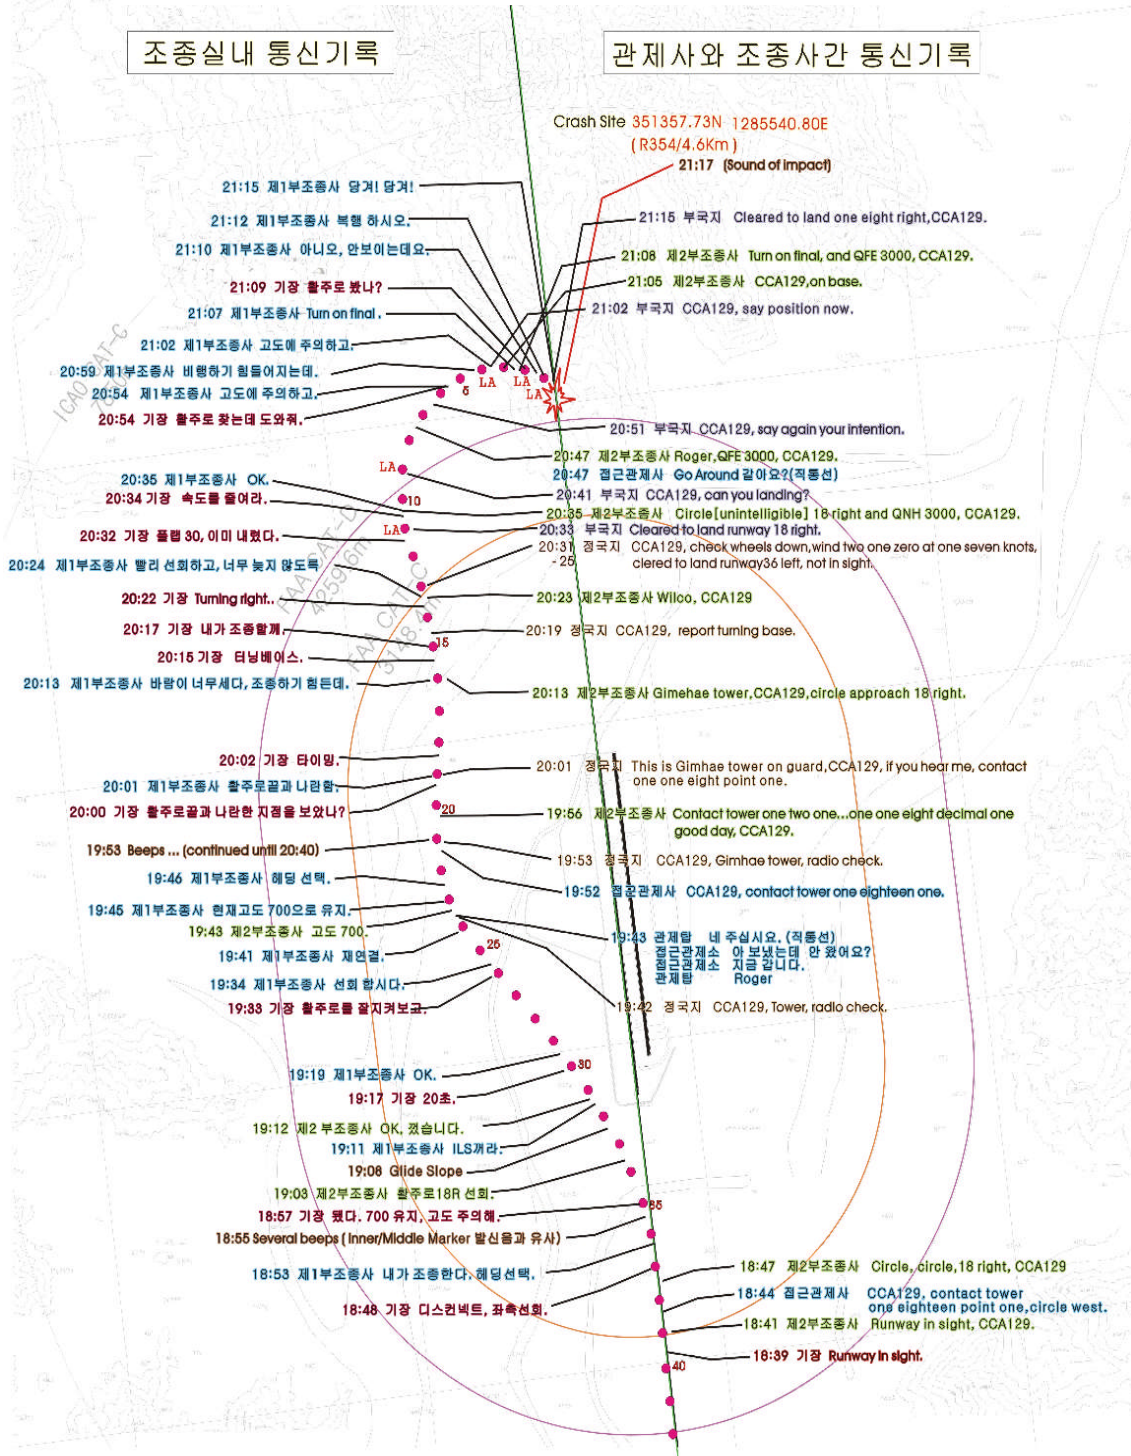
Figure 1-1 CVR & ATC Transcripts Plotted along the Flight Track from the FDR Data (Korean Version)

Figure 1-1 (in Korean) and Figure 1-2 (in English) depict the flight track from the pertinent FDR data, with the communications of CVR and ATC tape recording transcripts, plotted on the chart, during the circling approach at Gimhae airport, until the time of accident.

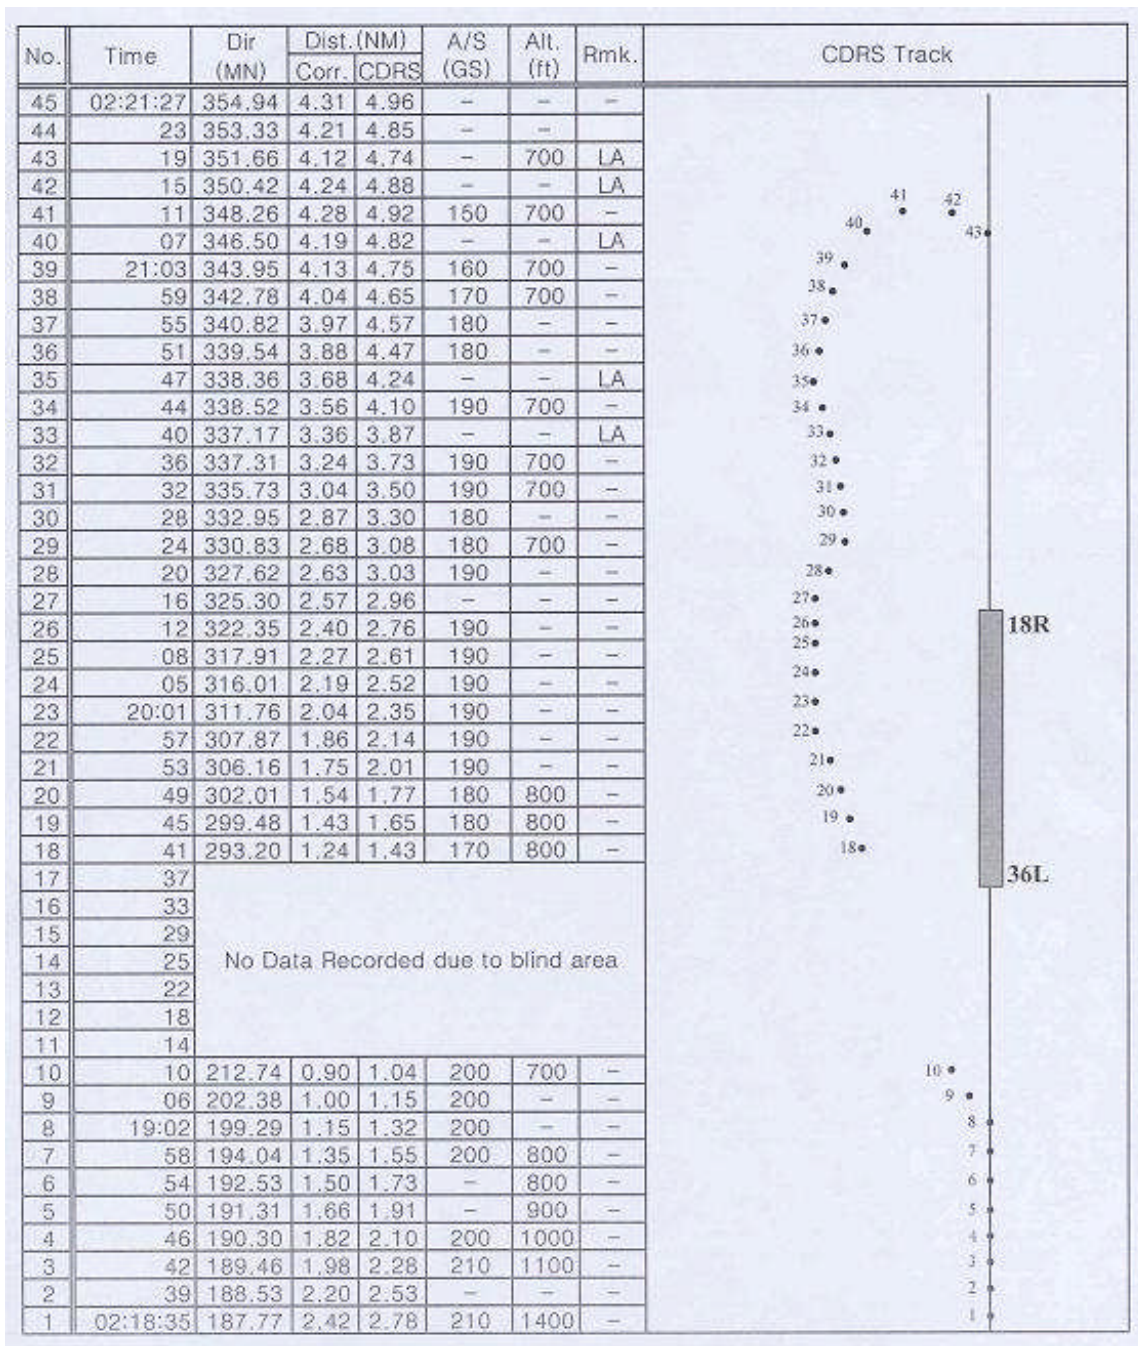
Figure 1-6 CDRS Data

\* Approximately 200 ~ 1,100 meters of difference existed from the final approach course to runway 36L to the crash point in the flight track on the drawing based on the CDRS data scaled one to 50,000, thus the CDRS data (distance) was multiplied by an invariable number 0.868976, and the revised the distance was calculated for the correction on the drawing. The flight track was composed on the basis of the revised data.

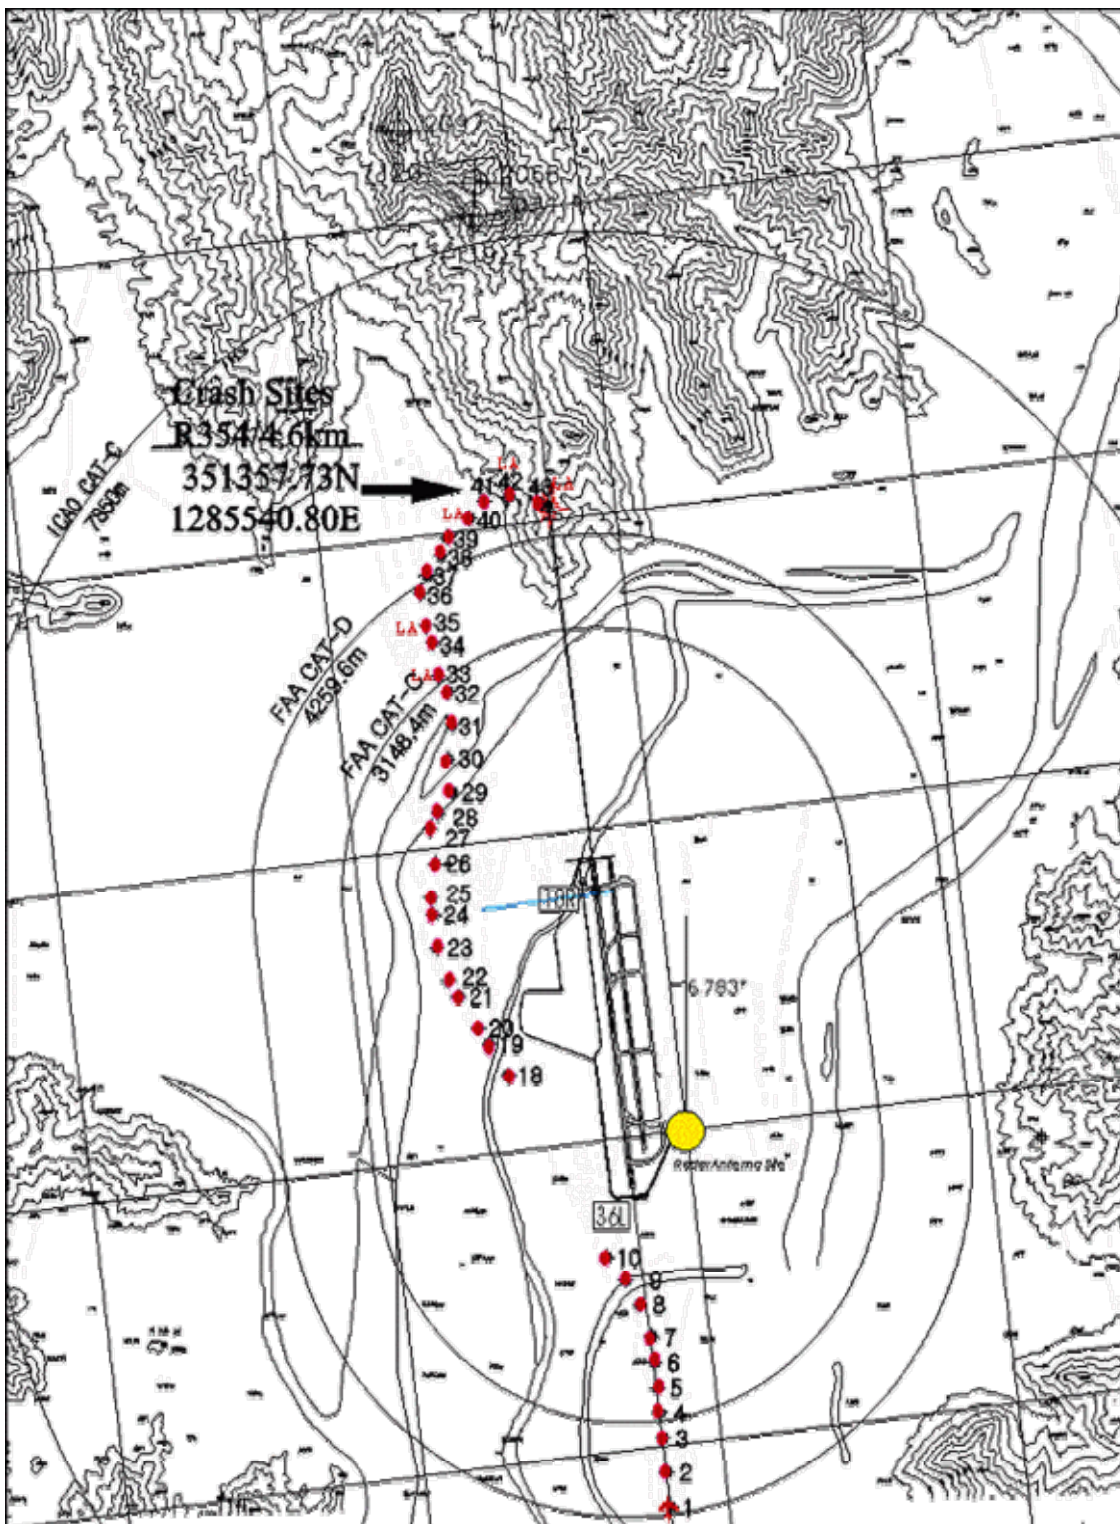
Figure 1-7 Circling Approach Radar Track of Flight 129 and Circling Approach Area

Figures 1-6 and 1-7 illustrate respectively the radar track data and the circling approach area of flight 129 during the circling approach to runway 18R.

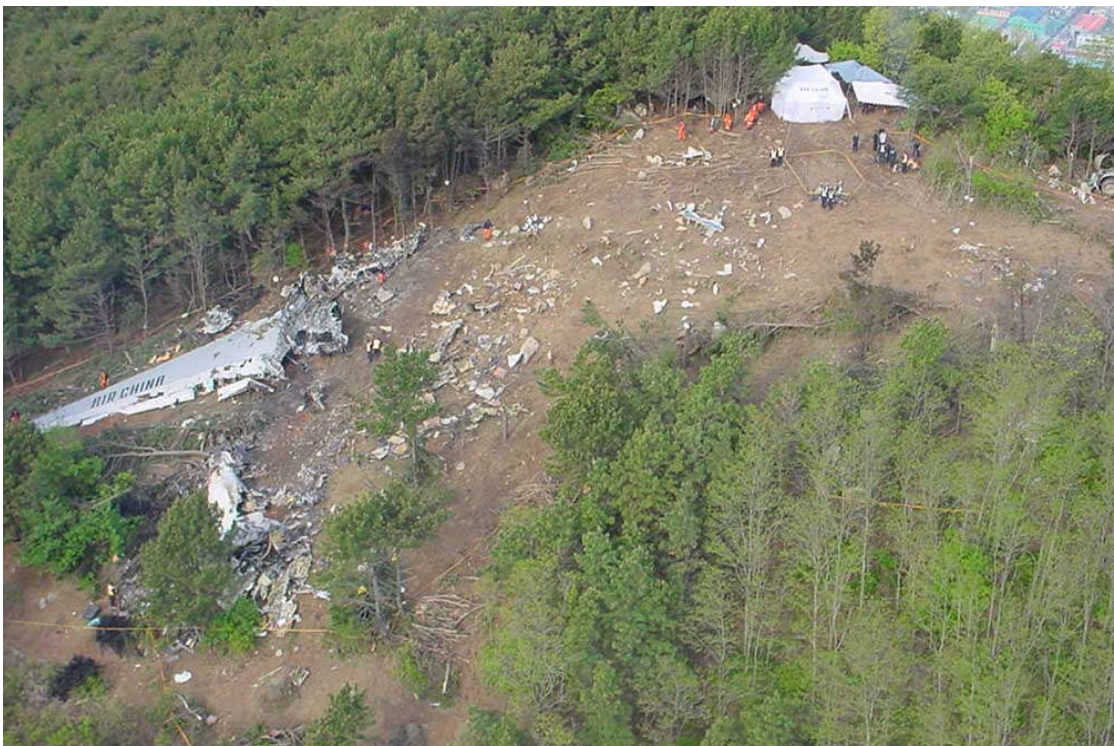
Figure 1-14 Photograph of the Accident Site

The investigation results on ground markings and the wreckage distribution pattern<sup>82</sup> showed the initial contact with terrain of an elevation of 204m, where the right wing struck trees. As shown on the Figures 1-13 and 1-14, the wreckage was scattered in an area about 200 m long and 100 m wide.

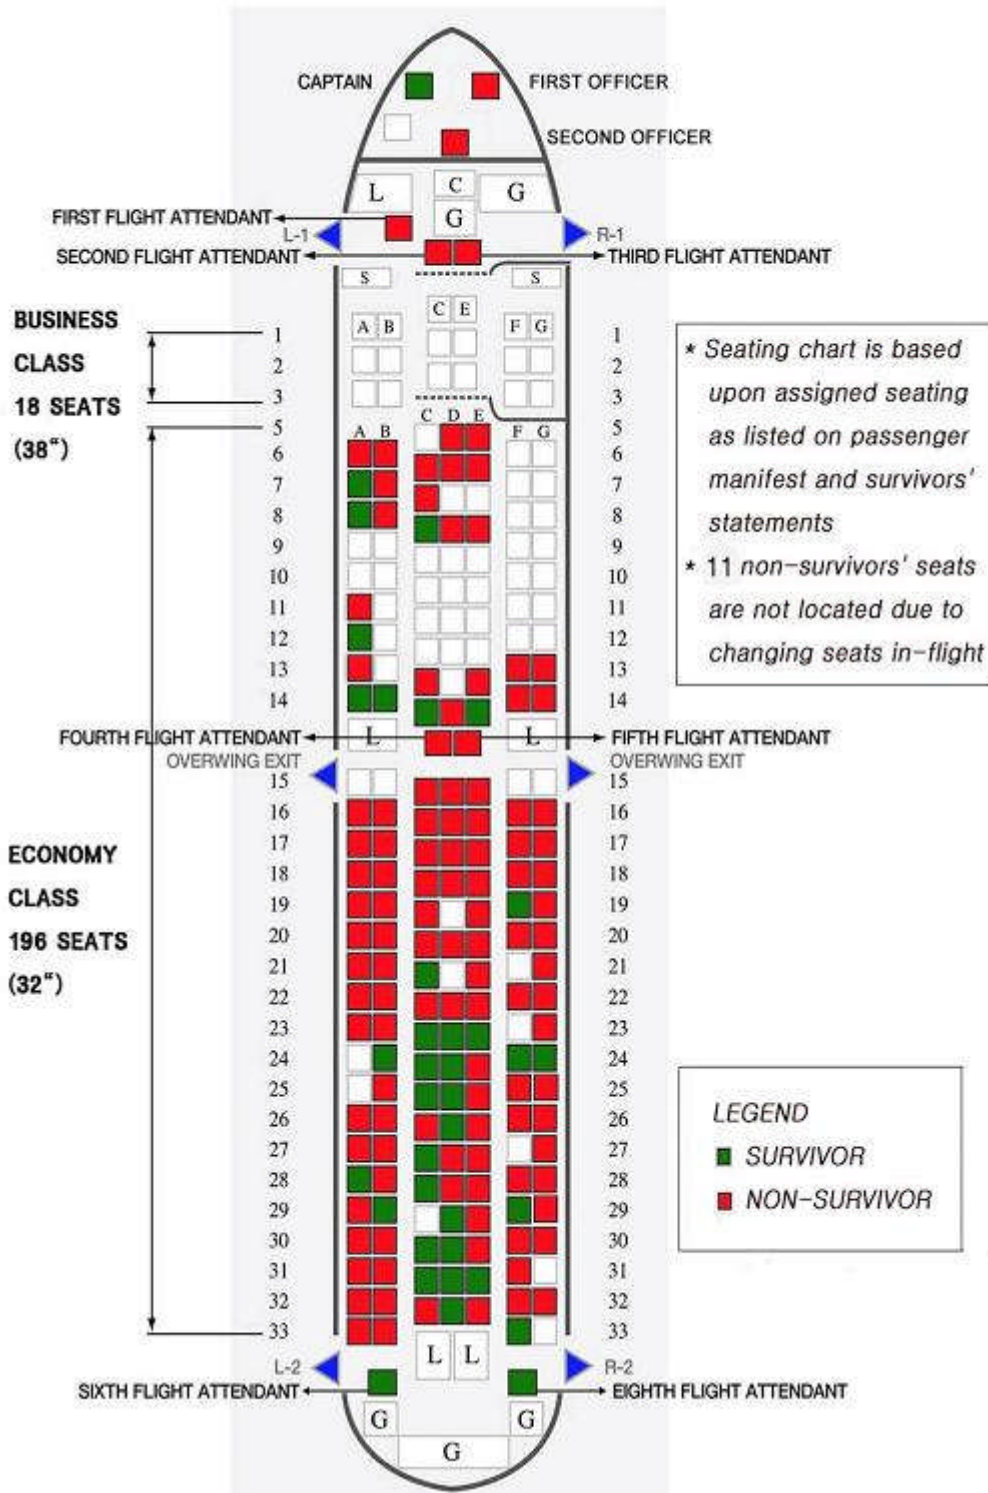
Figure 1-18 Seating Chart Showing the Location of the Occupants

Figure 1-18<sup>93</sup> shows that 8 of the 34 surviving passengers were seated in the economy class between rows 7 and 14, and out of these, 5 were seated on the left side and 3 in the middle seats. The seating for the other 26 surviving passengers was distributed from rows 19 to 33 in the back of the economy class, of which 3 were on the left side, 18 in the middle, and 5 on the right side.

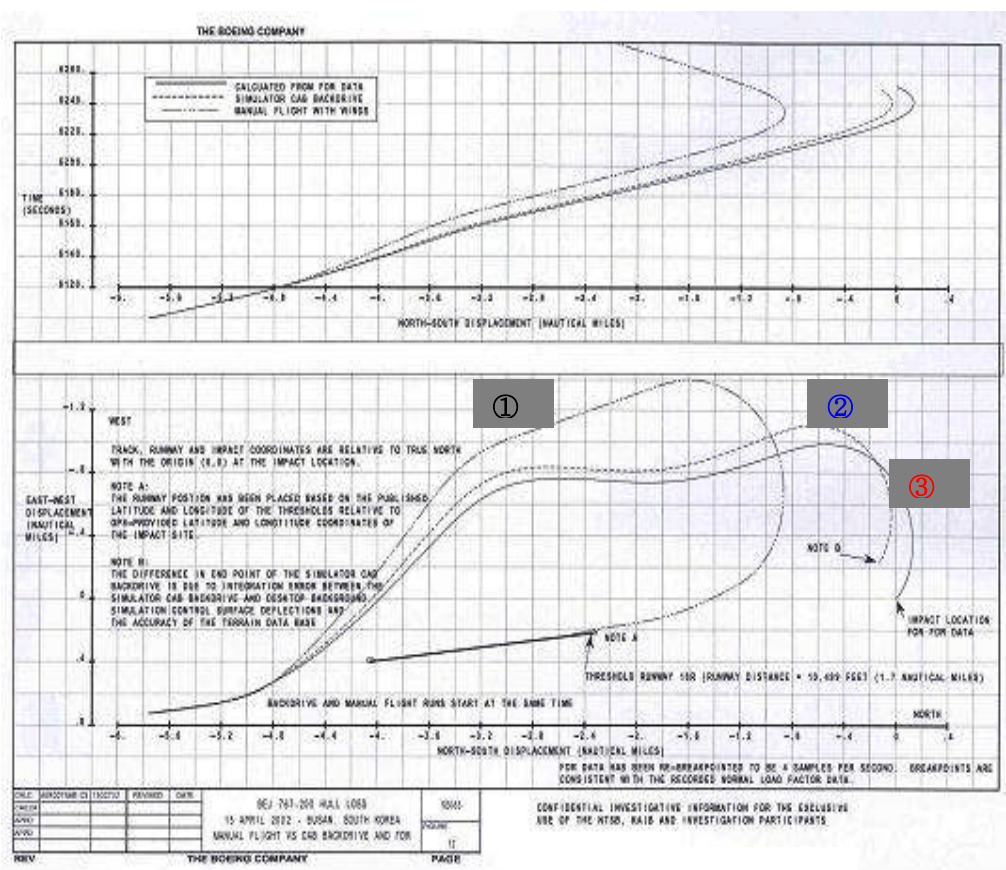
Figure 1-19 Flight Tracks from the Simulator Backdrive Session

The three tracks plotted on Figure 1-19 began from the same starting point, where: ① manual circling approach maneuvering track with wind corrected heading and 20 seconds time check; ② the backdrive cab track; and ③ the FDR track are shown.

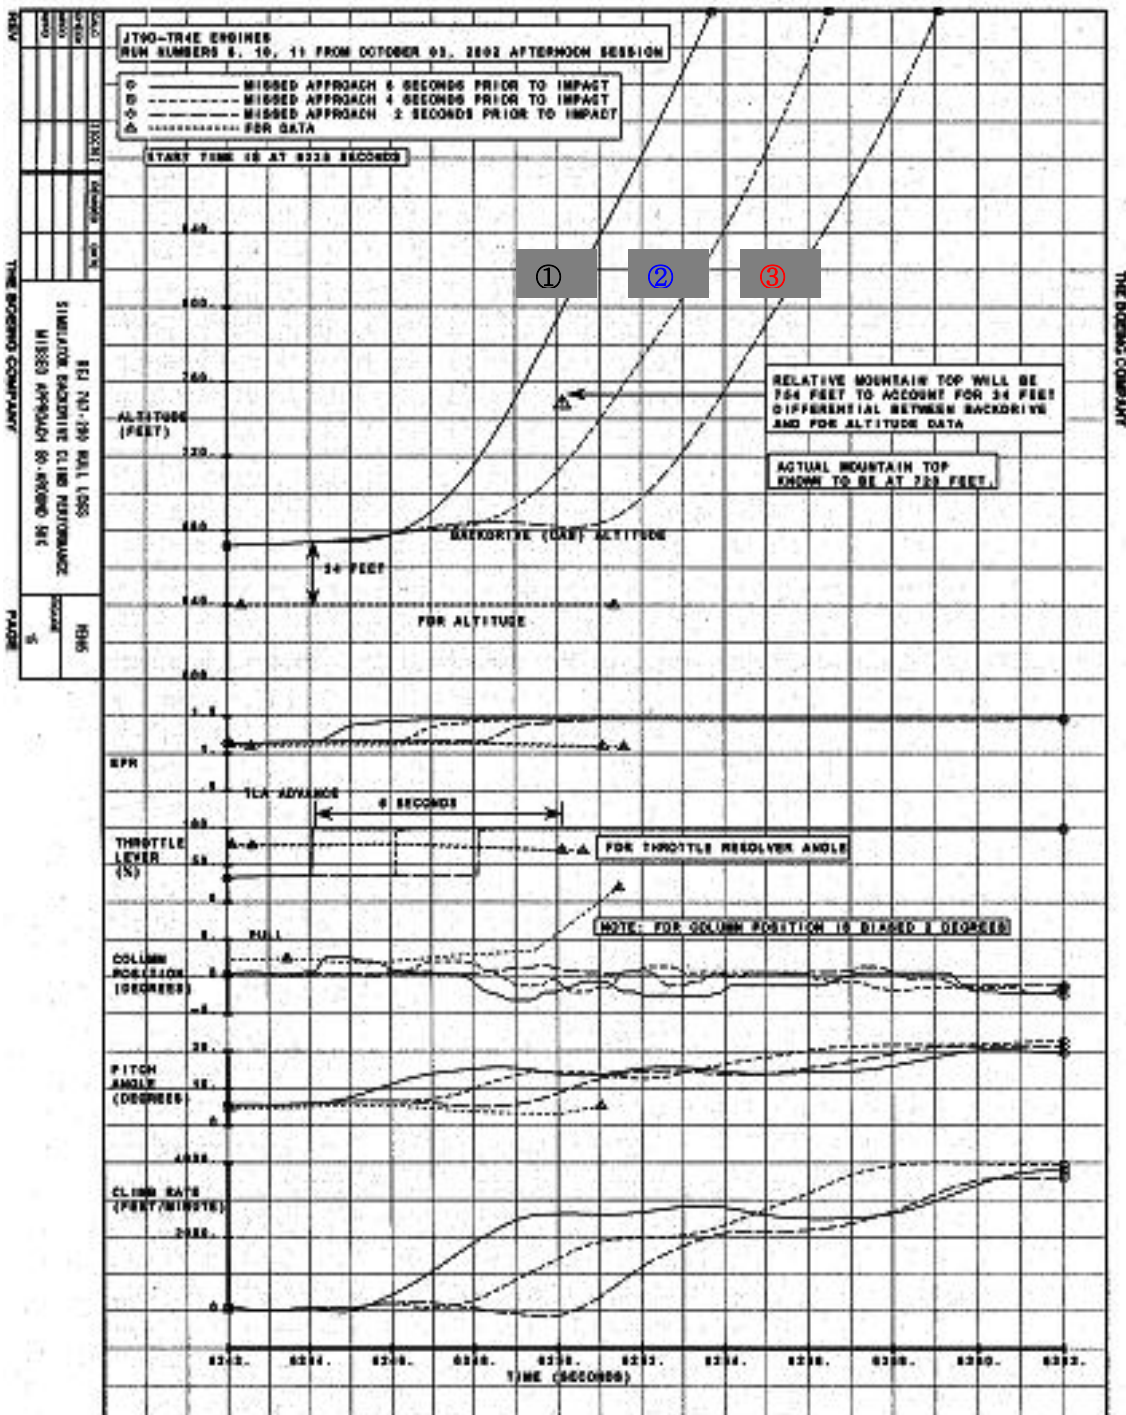
Figure 1-20 Climb Performance Data, Missed Approach Maneuver

Both go around and terrain avoidance maneuvers showed the aircraft clearing the mountain when either maneuver was performed 6 seconds prior to impact.
